**HISTORIC PRESERVATION REVIEW BOARD
STAFF REPORT AND RECOMMENDATION**

Landmark/District: **Mount Pleasant Historic District** (x) Agenda
Address: **2021 Klingle Road NW**

Meeting Date: **July 9, 2015**
Case Number: **15-427** (x) Alteration

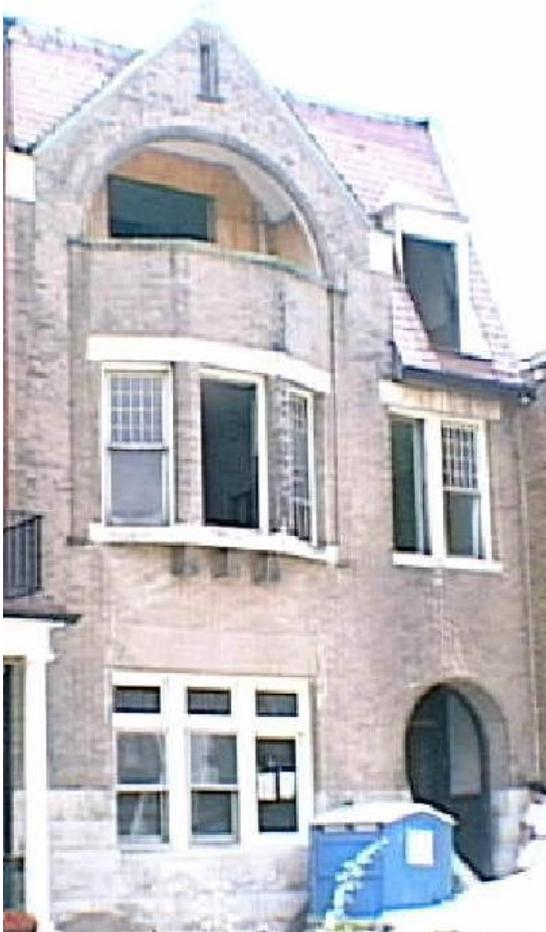
1466 Belmont Street NW

One can trace Mindeleff’s efforts to render his Romanesque-influenced masonry work into frame construction, something that John Ruskin would have condemned as lacking “truth,” but which provided interesting reveals and shady porches. Compare his semidetached 1466 Belmont Street NW, designed in 1894, with the 3325 Holmead Place cottage of two years earlier (see next page) and with the French House. In each case, the principal feature is a porch recessed behind a projecting balcony and beneath an arch. Holmead Place has a Gothic arch, suggestive of cruck framing. Both of the earlier homes may be seen as prototypes for the French House, but the latter is freed from the idea that the arch is structural, and its upper porch is nestled into the roof of the principal one.⁵
